Debris/Ice/TPS Assessment And Photographic Analysis For Shuttle Mission STS-48

November 1991

Gregory N. Katnik
NASA/Kennedy Space Center

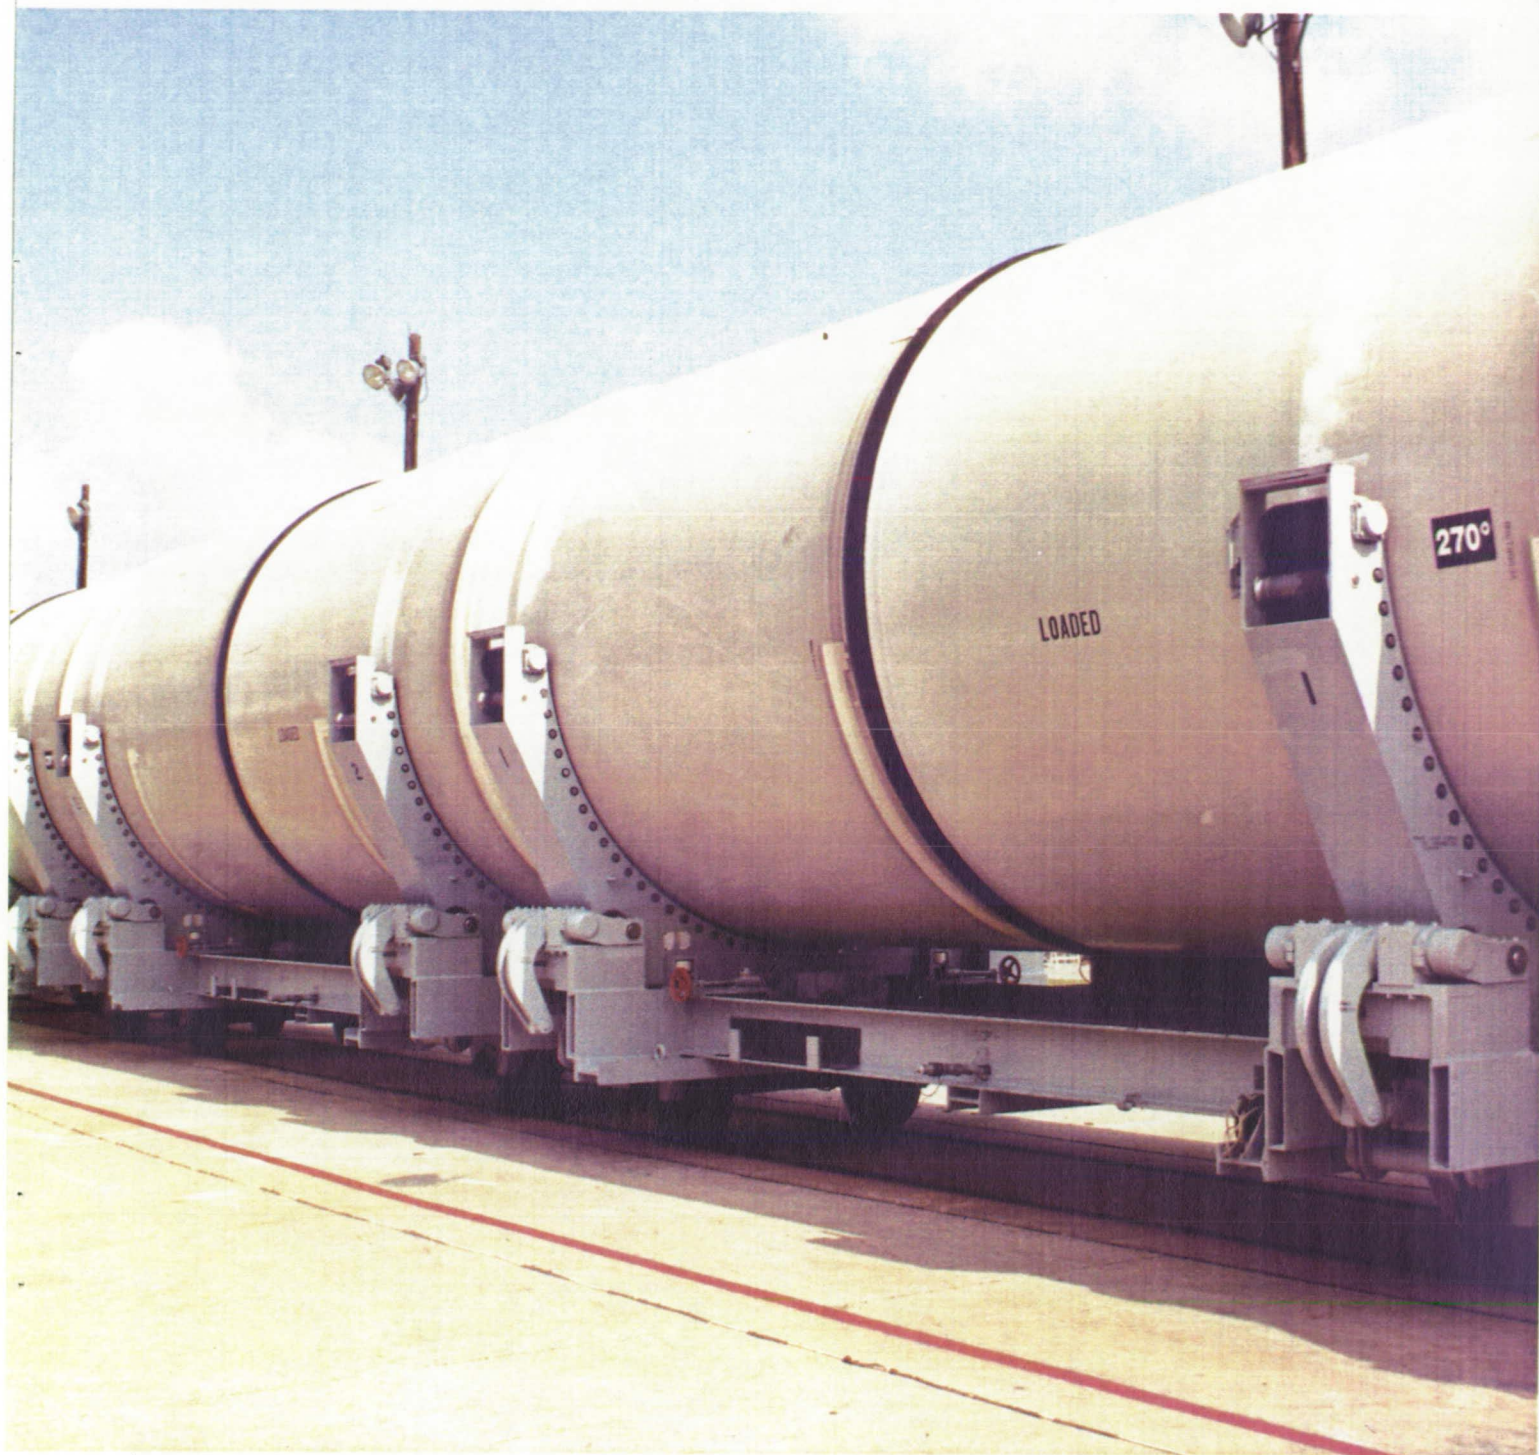
Overall view of the RH SRM cases. The Field Joint Protection System closeouts were generally in good condition.

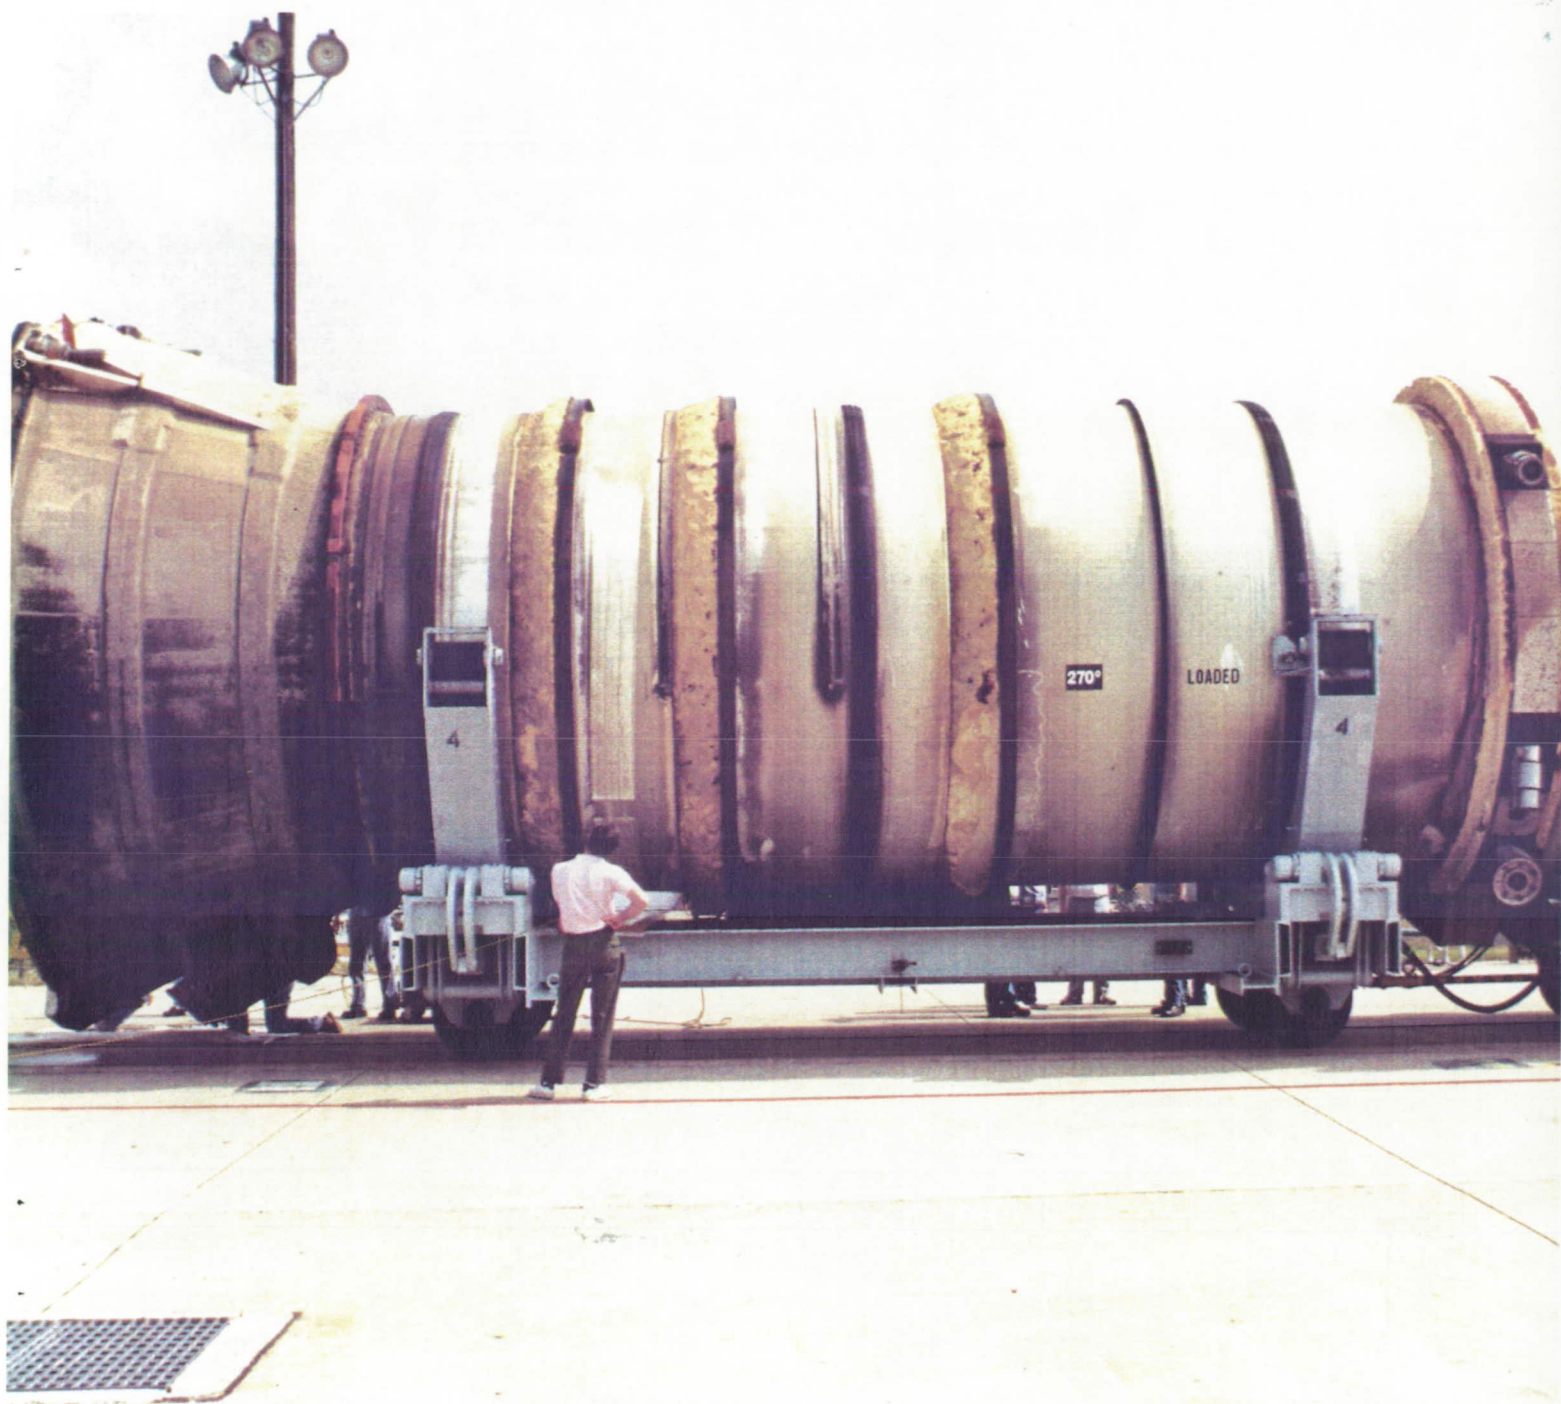
Post flight condition of the RH aft booster. The aft skirt acreage TPS was sooted but in good condition.

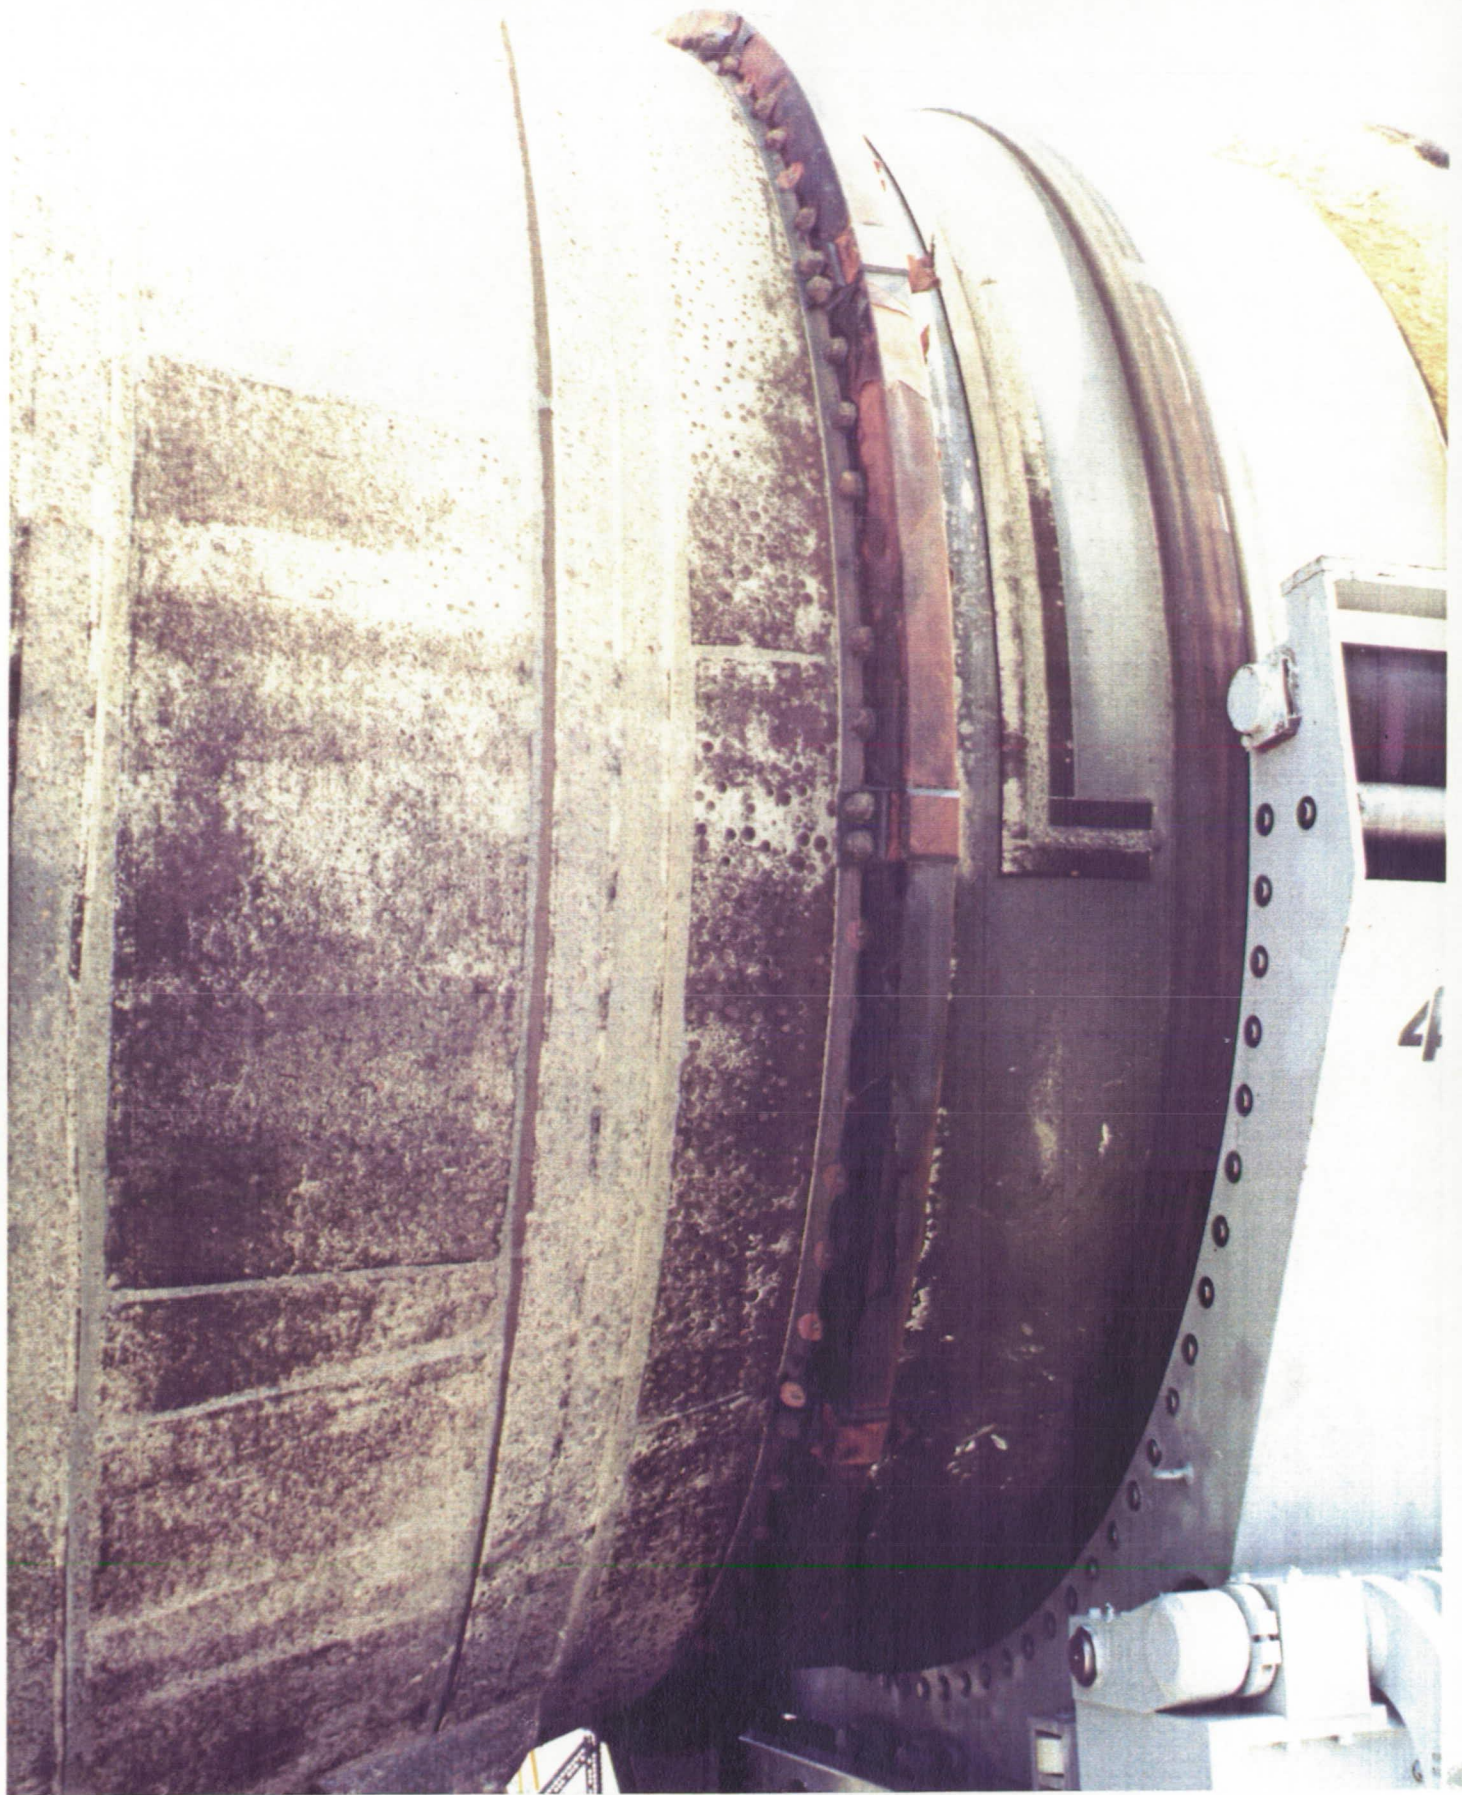
K5NA protective domes were lost from bolt heads on the aft side of the phenolic kick ring prior to water impact and exhibited a sooted substrate.

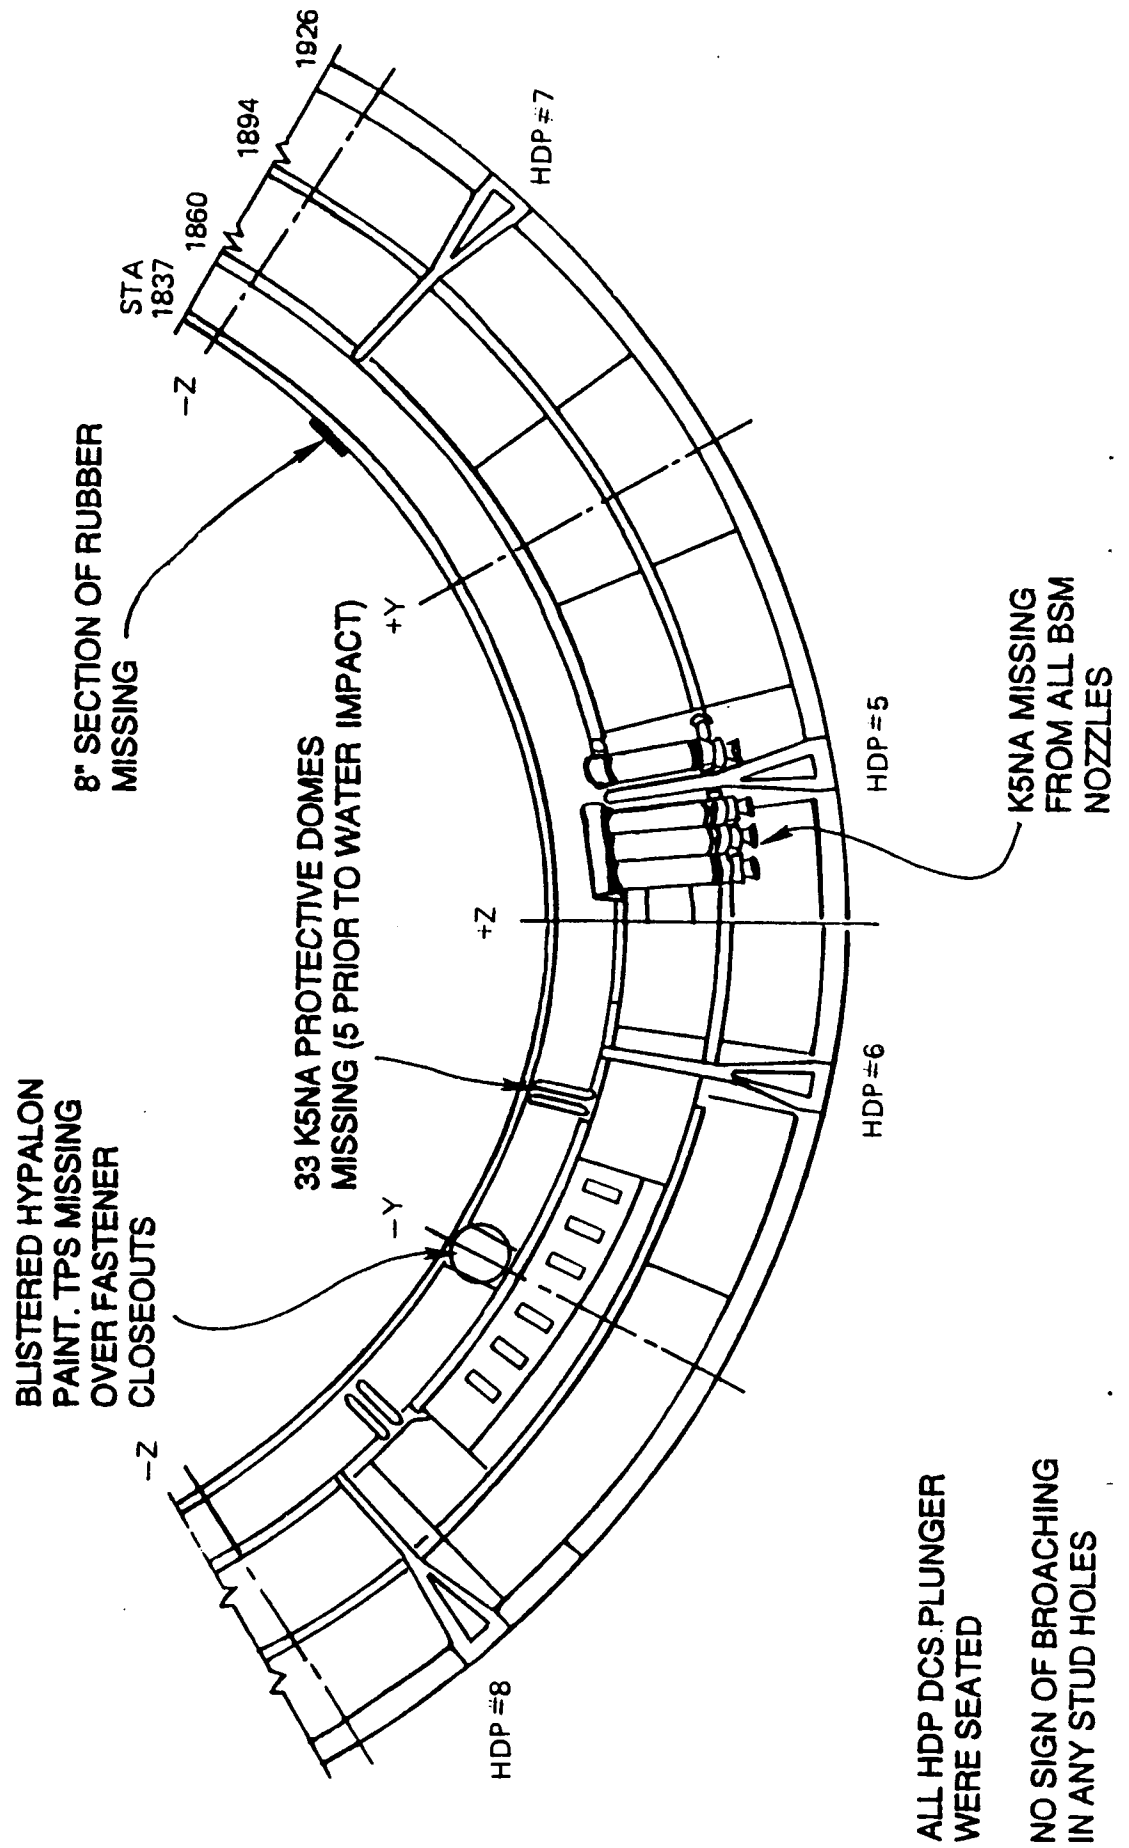
FIGURE 10. LEFT SRB AFT SKIRT EXTERIOR TPS

The phenolic material on the kick ring delaminated at several locations. Thirty-three K5NA protective dome were missing from bolt heads on the aft side of the phenolic kick ring. Five of these domes were lost prior to water impact (charred substrate). The aft skirt acreage TPS was in good condition. K5NA was missing from all aft BSM nozzles (Figure 10).

SOME LOCALIZED BLISTERING OF HYPALON PAINT AROUND
PROTUBERANCES

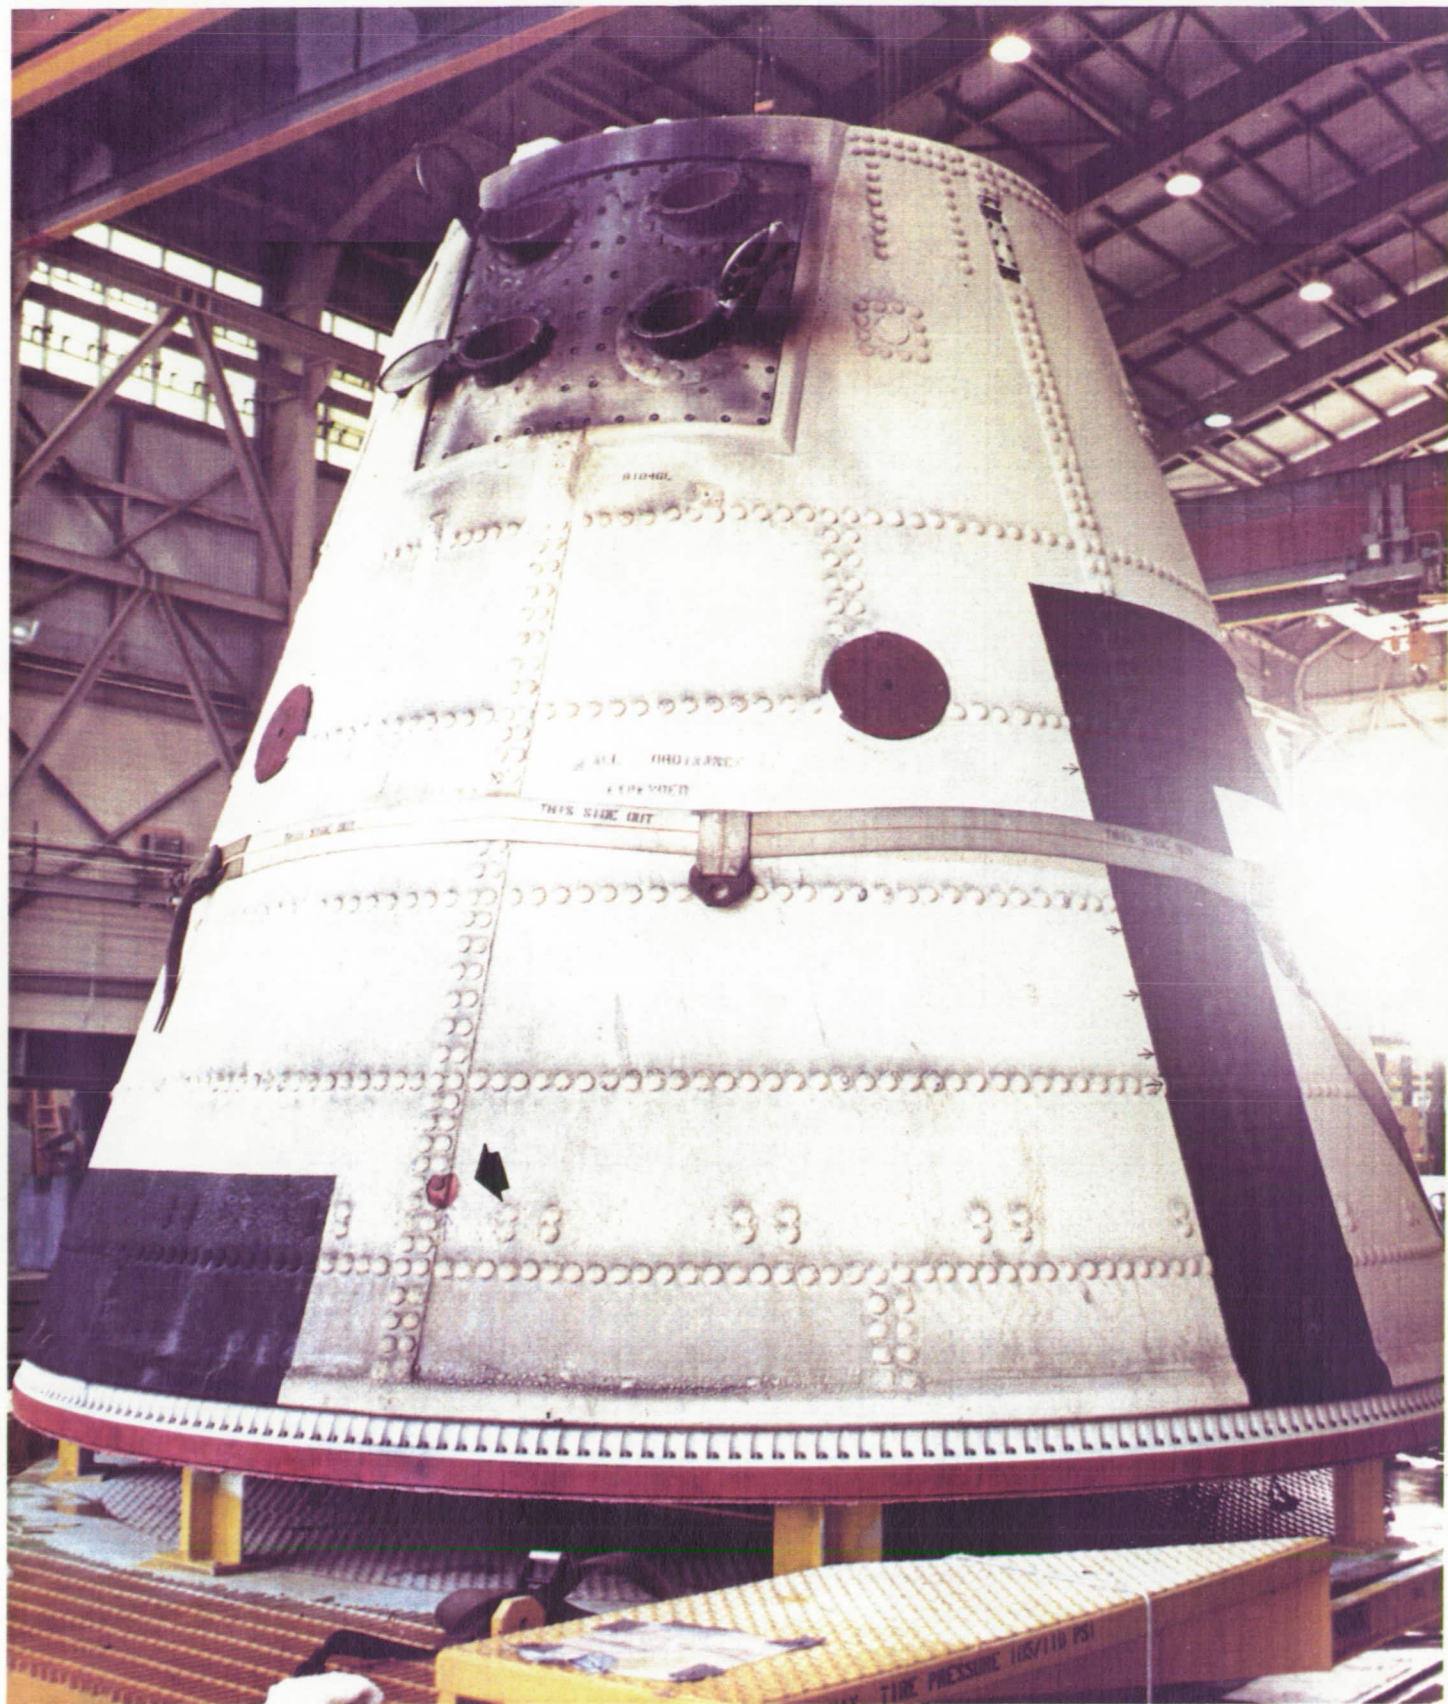
The LH frustum had 51 MSA-2 debonds over fasteners. Damage occurred to the forward BSM aero heatshield covers/attach rings and a piece of MSA-2 was missing near the 381 ring. BSM residue and sooting were typical. There was no evidence that unusual aerodynamic loading had occurred on the frustum.

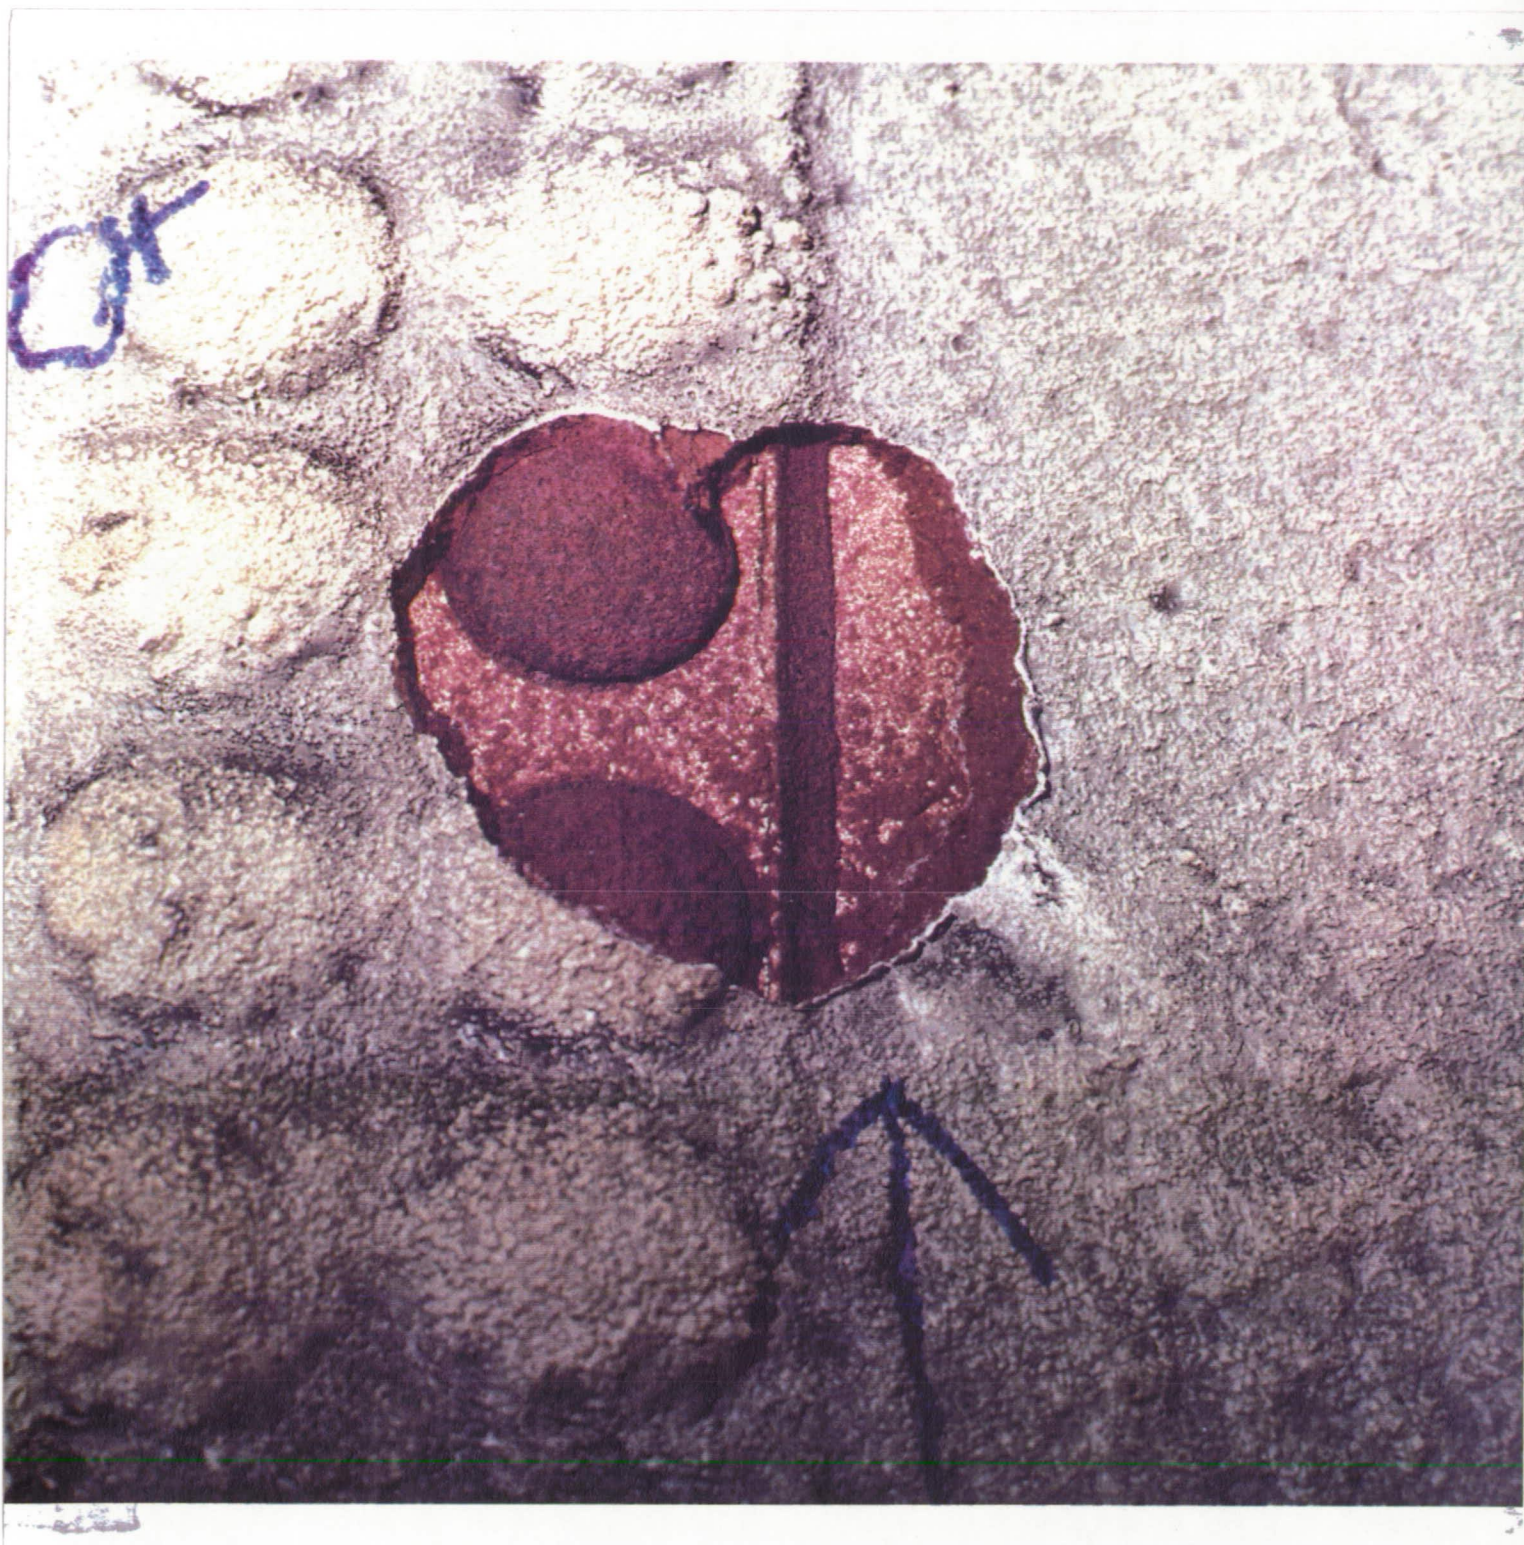
A 2.9" x 2.75" area of MSA-2 was missing from the LH frustum on the stiffener below the BSM's near the 381 ring. A laboratory analysis was performed at MSFC on the MSA-2 divot area. Examination of the surrounding material showed that the exposed surfaces were clean and free of sooting/charring/ heat effects in an aero-thermal environment. Hypalon peelback occurred laterally and was not in the direction of the nosecone (forward flight). The report concluded the MSA-2 was lost either during the late stages of descent, at water impact, or during retrieval operations.

A 2.9" x 2.75" area of MSA-2 was missing near the 381 ring. The MSA-2 had separated completely from the substrate. The exposed surfaces of the surrounding material were clean and free of sooting/charring/heat effects. Hypalon peelback occurred laterally and was not in the direction of the nosecone. The MSA-2 was lost during the later stages of descent, at water impact, or during retrieval operations.

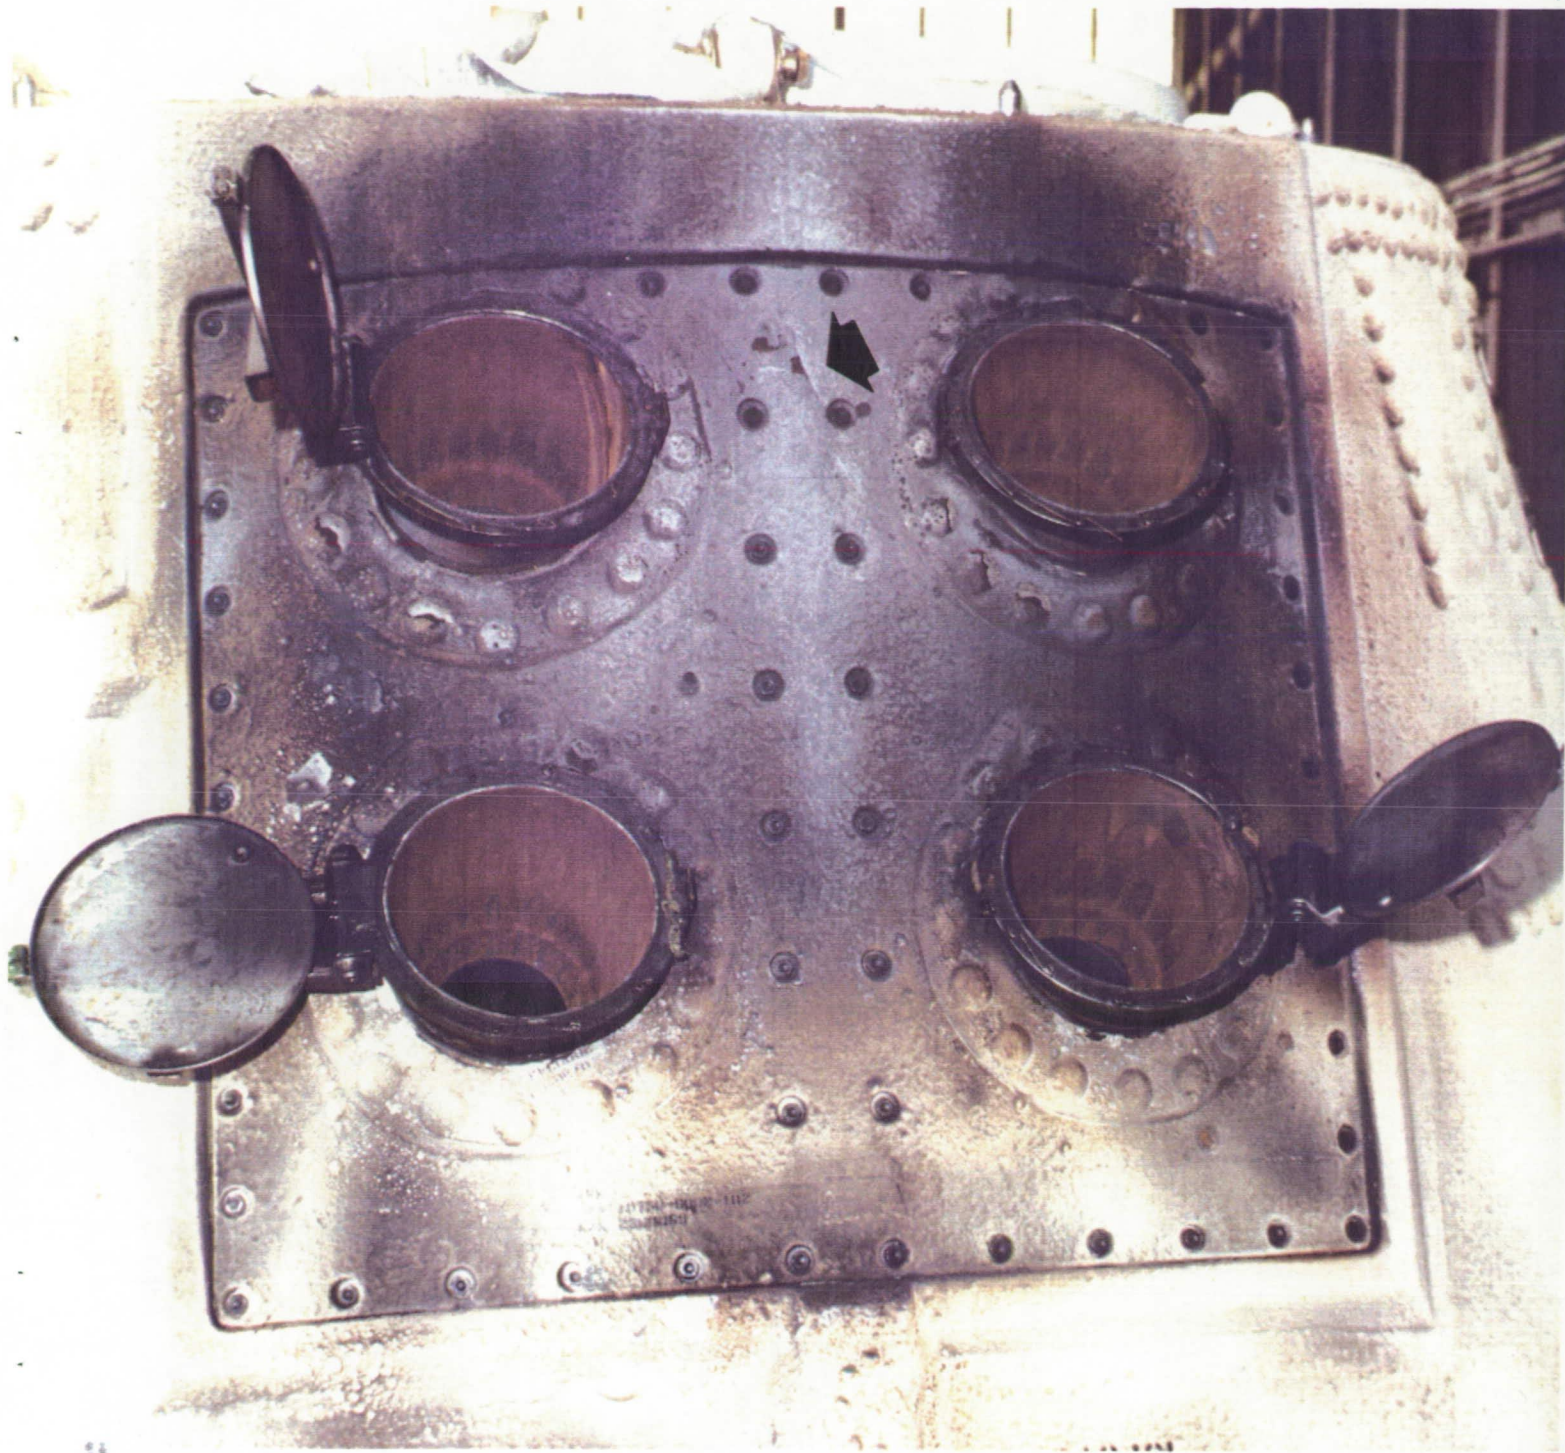
The upper left and lower right BSM covers on the LH frustum had locked in the fully opened position and then had been subsequently deformed. The lower right attach ring was fractured at one location. The upper right BSM cover was missing. The substrate at the fracture planes, including the threads of the exposed screws, were sooted. Curved TPS cuts/substrate indentations near the location of the missing cover matched the size of a BSM cover lip. A laboratory analysis was performed on the remaining attach hardware of the missing aero heatshield cover. It should be noted that covers have been lost on seven previous flights (STS-2, 3, 4, 9, 11, 17, 28) and were attributed to re-entry, water impact, or retrieval operations. The analysis of the STS-48 damage showed that the cover did not fail prior to BSM firing. (Radar data at the time of BSM firing and SRB separation could not conclusively prove the forward BSM cover came off in the vicinity of the Orbiter). There were no unusual aero loads during the ascent and separation phases which could cause the loss of the cover. (Max Q for the SRB's occurs during re-entry). A gouge in the cork, which was attributed to an impact from the lost cover, just forward and between the two upper cover positions negated the possibility of losing the cover during ascent or separation. The MSFC study concluded the cover came off during re-entry and was not a debris threat to the Orbiter. However, the report did not explain why normal aerodynamic loading during re-entry caused this kind of damage. The IFA was closed based on the results of the study.

The LH frustum upper left and lower right BSM aero heatshield cover attach rings/hinges were deformed. The upper right cover was missing and the attach ring/hinge exhibited a ductile failure. Curved TPS cuts/substrate indentations (arrow) near the location of the missing cover matched the size of a BSM cover lip.

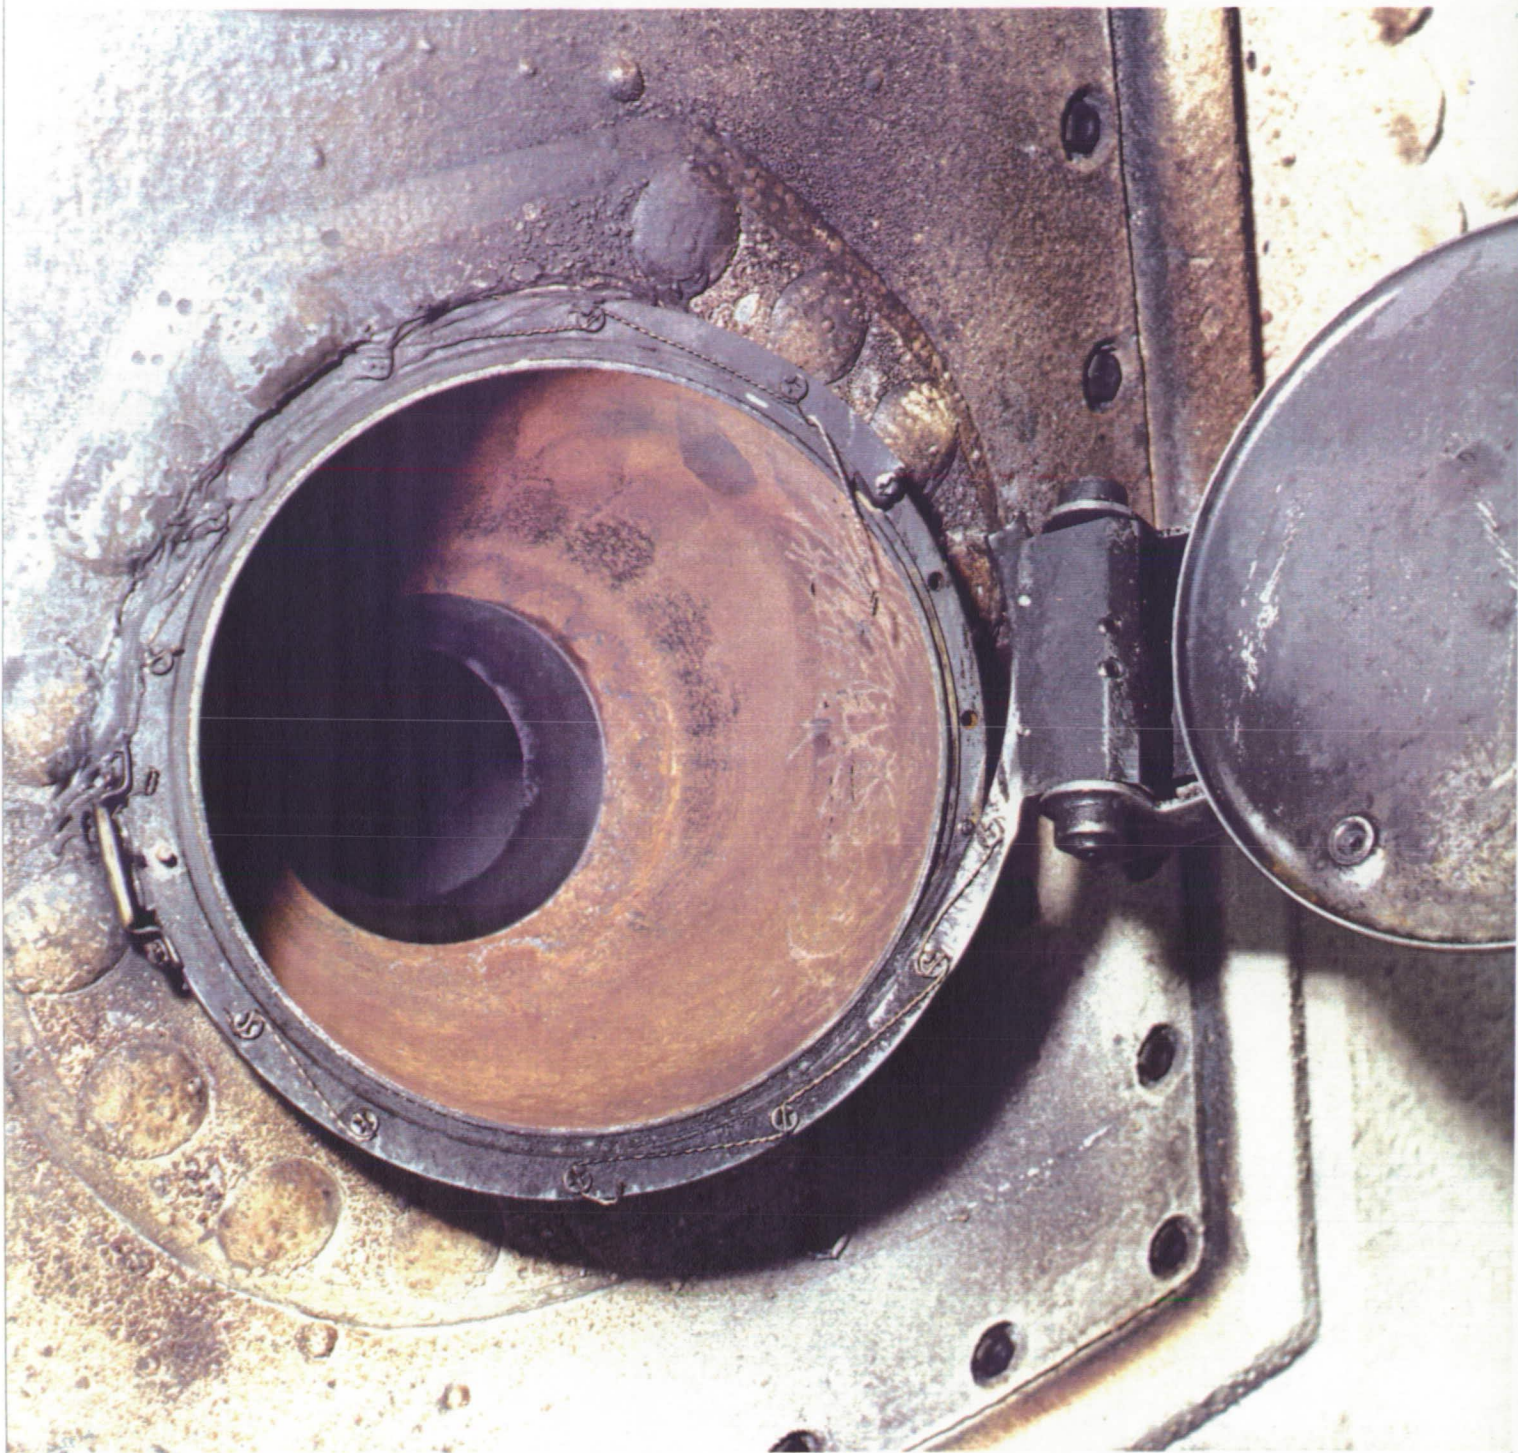
The lower right BSM aero heatshield cover attach ring/hinge had been deformed some time after being locked in the fully opened position. The attach ring was fractured at one location.

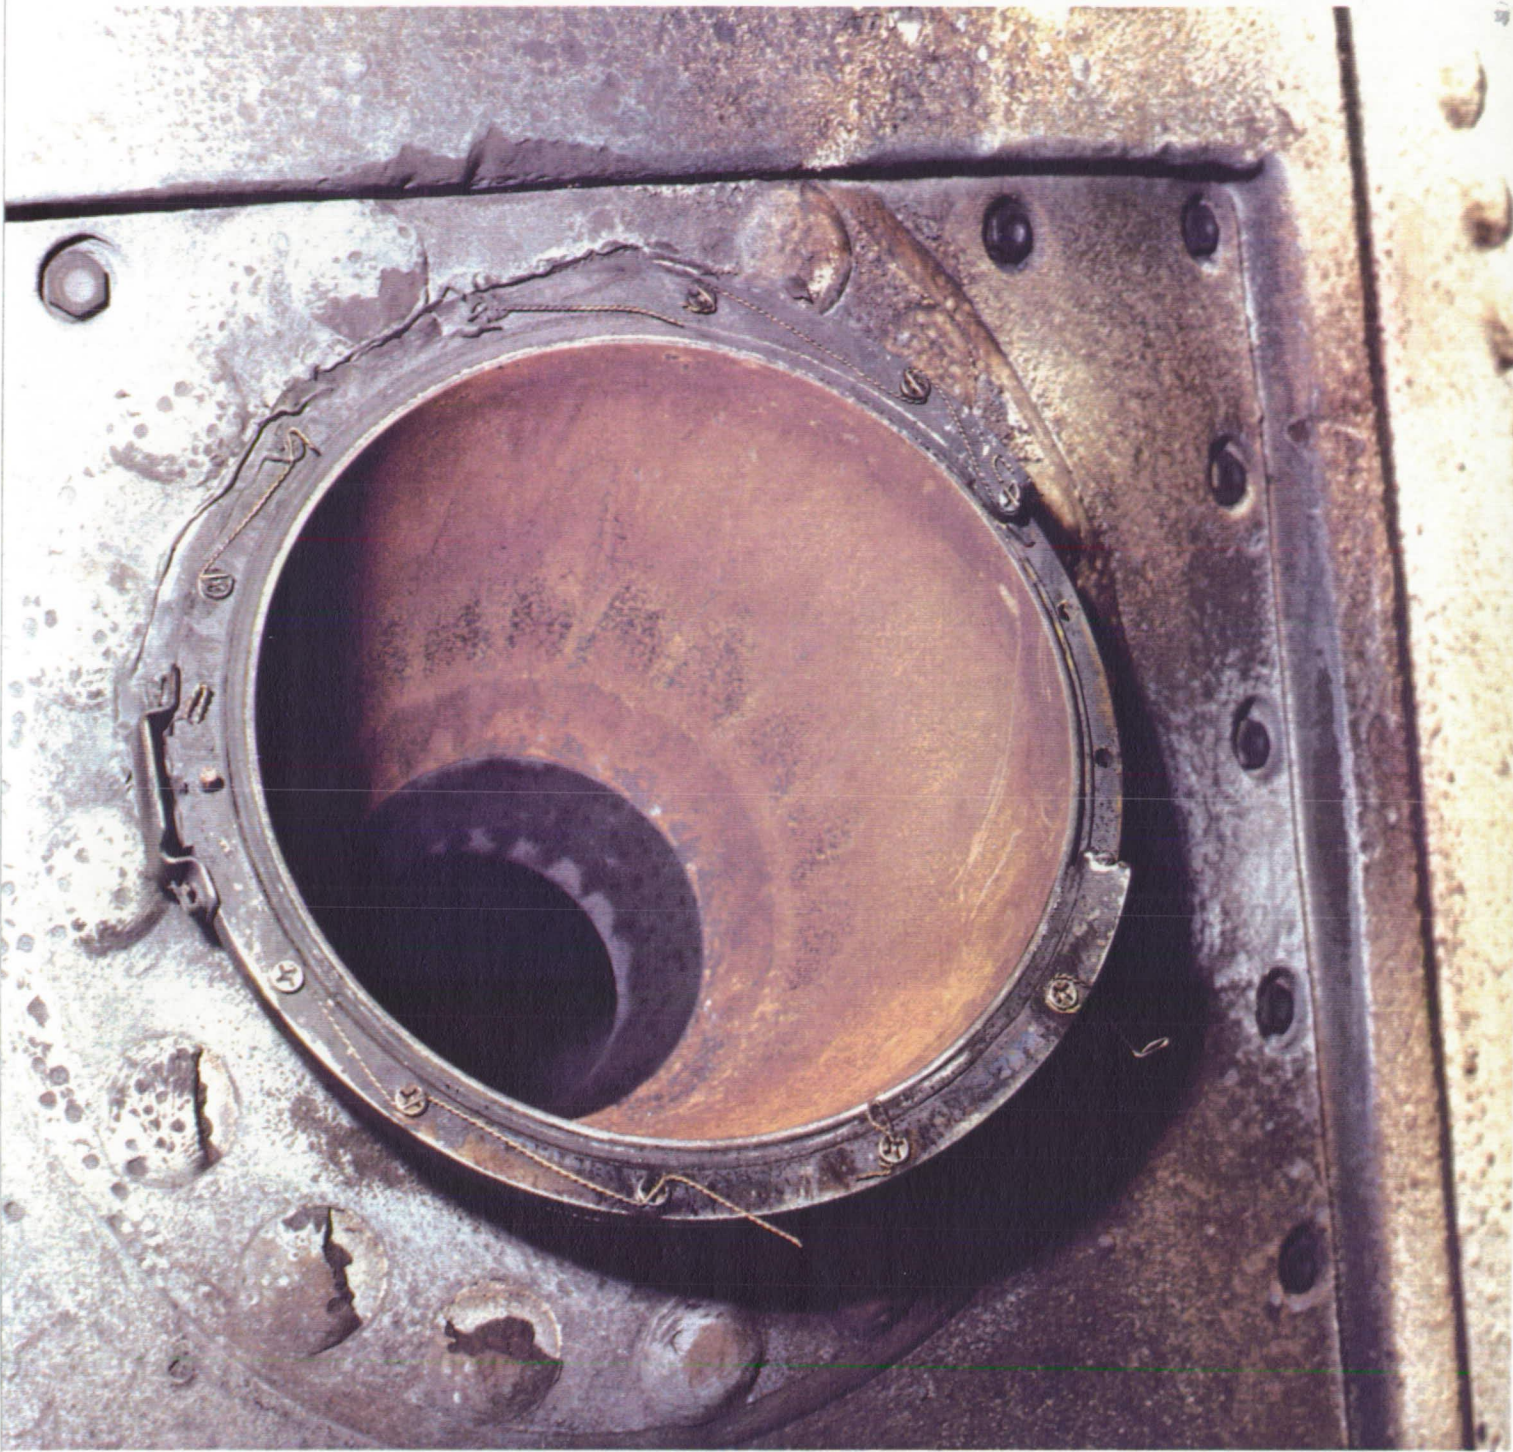
The substrate at the fracture planes, including the threads of the exposed screws, were sooted. MSFC laboratory analysis of the attach ring concluded the failure did not occur prior to or during BSM firing. There were no unusual aerodynamic loads during ascent or descent that could have caused the failure. SRB Max Q occurs during re-entry.
